Walk Around

Fw 190D

By E. Brown Ryle and Malcolm Laing

Focke-Wulf Fw 190D-9

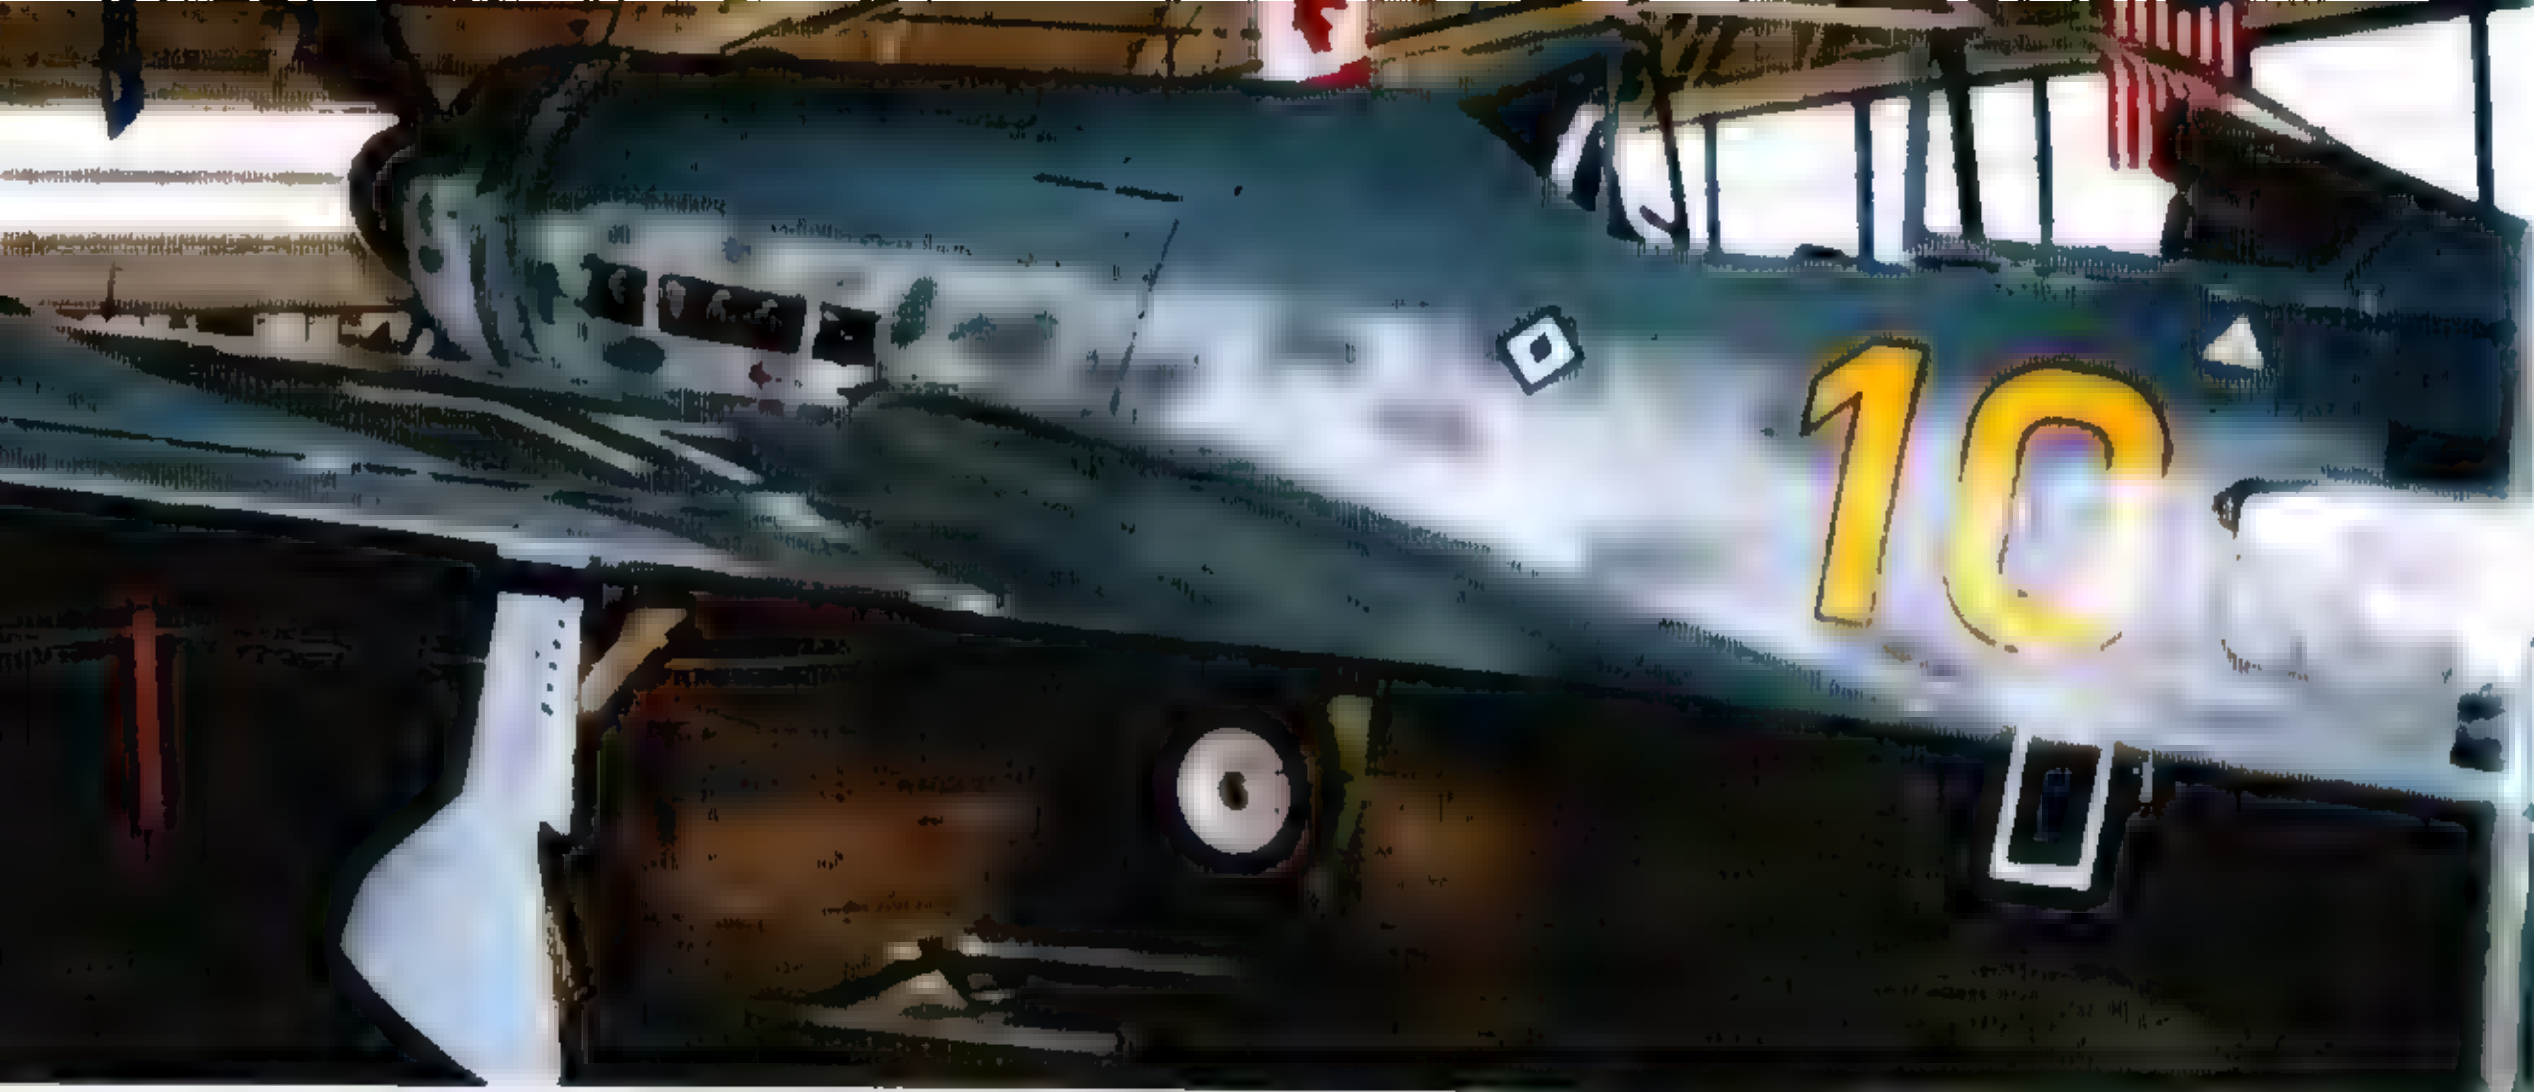
(Above) The port side of the Champlin Fighter Aces Museum 190D-13. It is believed that this was the 17th Fw 190D-13 manufactured. Built by Roland in March of 1945, the fuselage for Fw 190D-13 was rebuilt from an Fw 190A-8 airframe (174, which had been produced at the Focke-Wulf plant at Cottbus in May of 1944. This rebuilding of usable airframes was a common practice with Fw 190 production. (Author: Ryle)

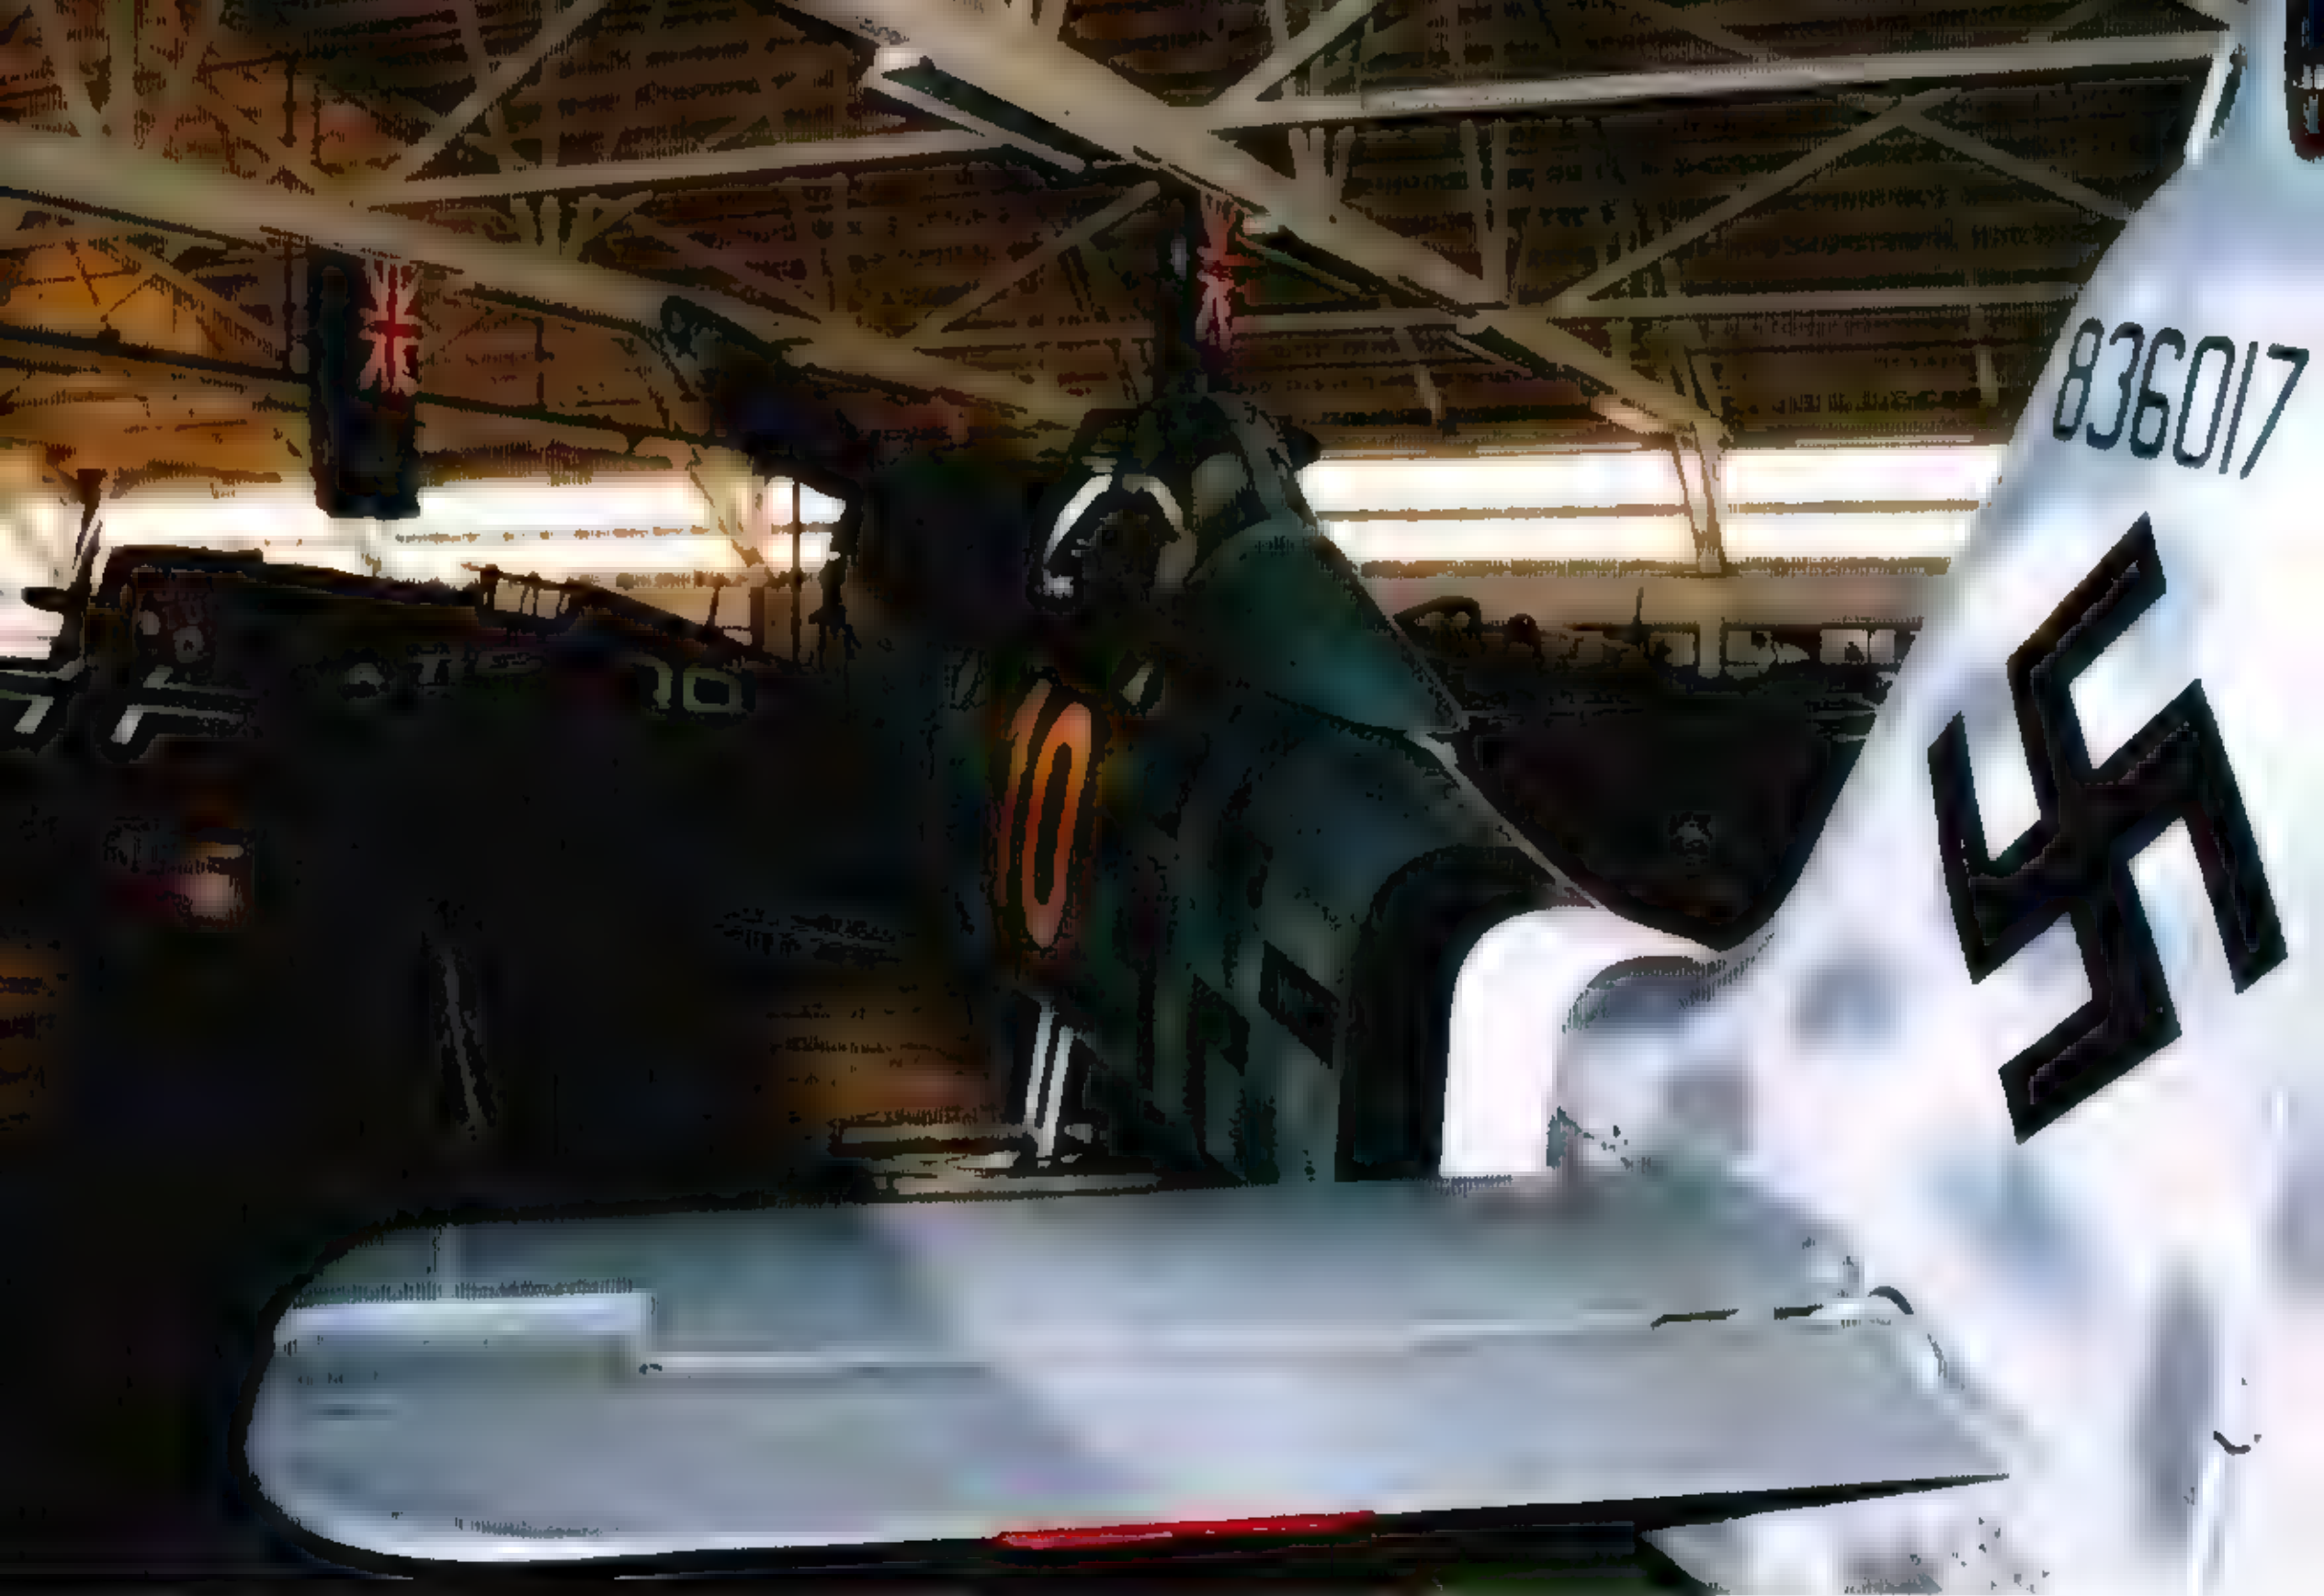
The trailing edge of the horizontal stabilizer along with its connection to the elevator. The aircraft's Work Number (836017) is at the top of the vertical fin. The placement of the Work Number in this location was a standard practice throughout the war. (Author: Ryle)

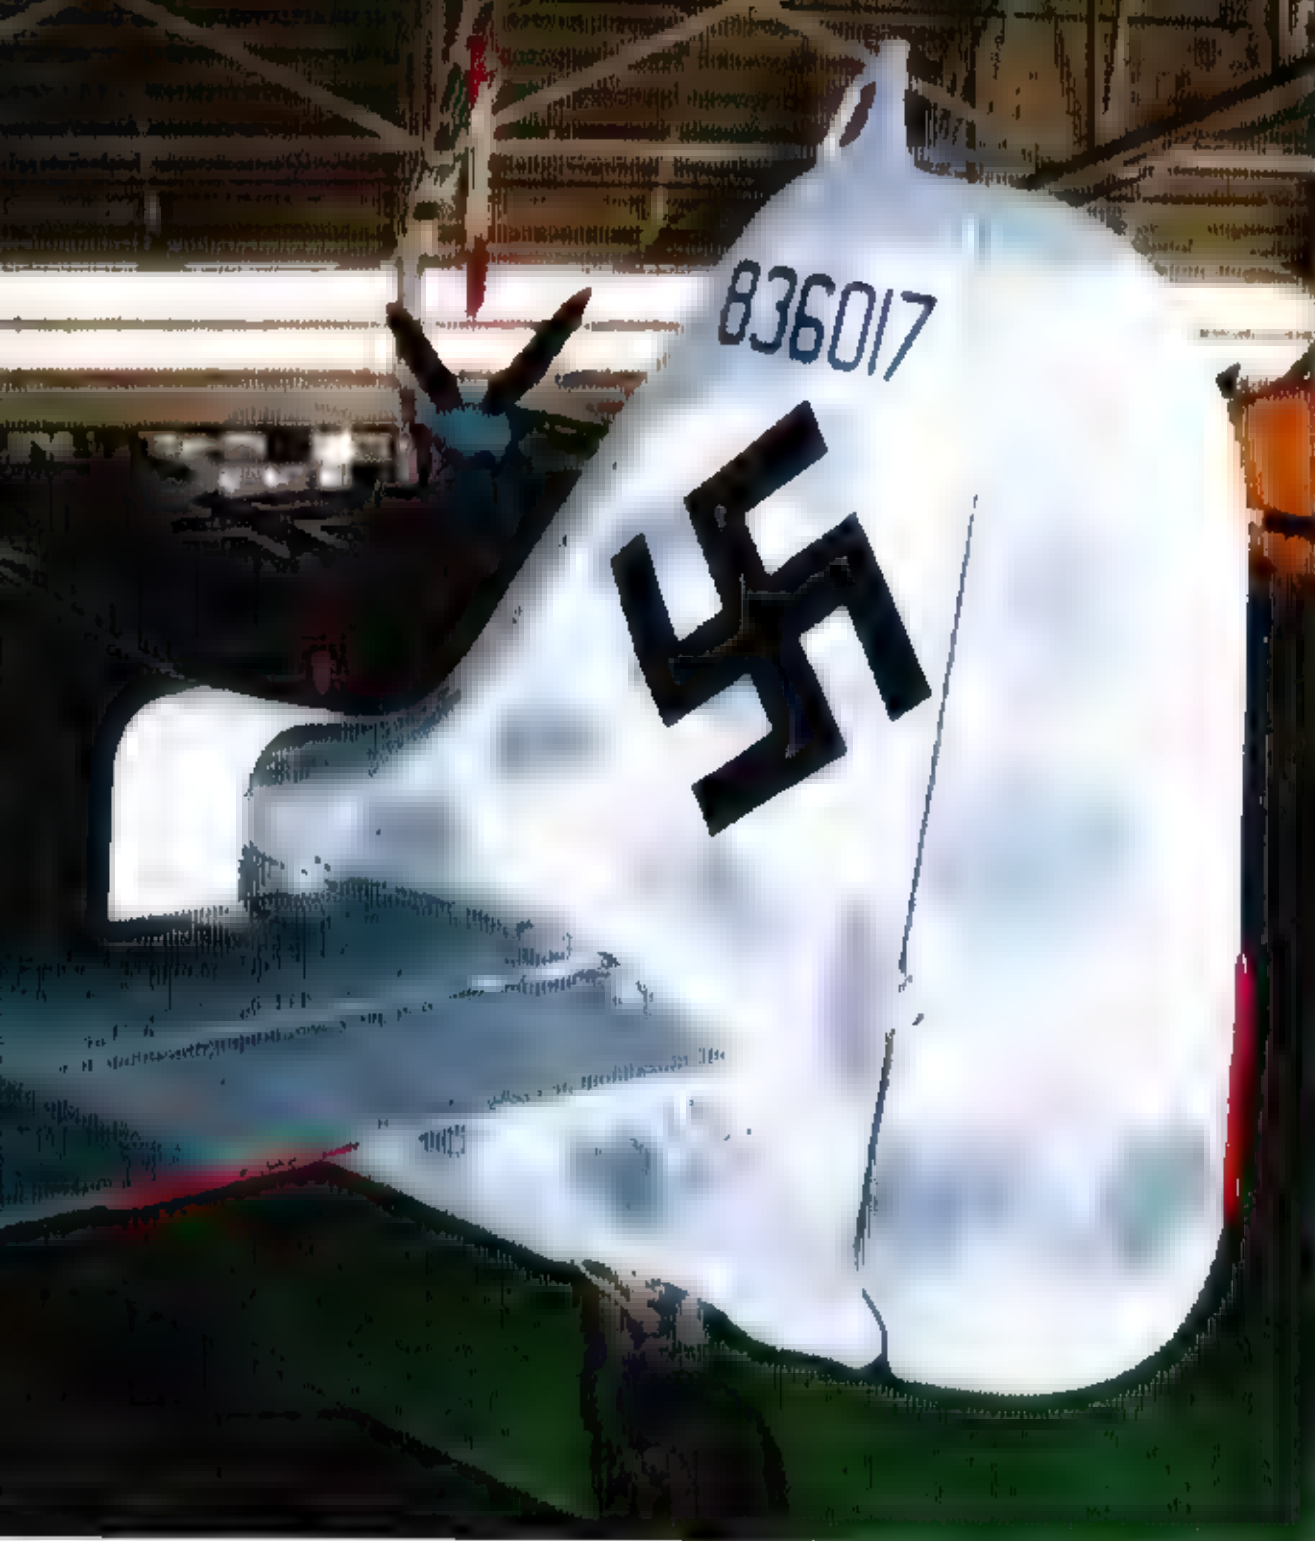
(Above) The tail assembly of Fw 190D-13 has the Work Number, 836017, positioned on both sides of the tail. Often the entire Work Number appeared on the port side, with only the last three digits being repeated on the starboard side. The antenna post on the vertical stabilizer has been replaced and the rudder is a replica. (Author: Ryle)

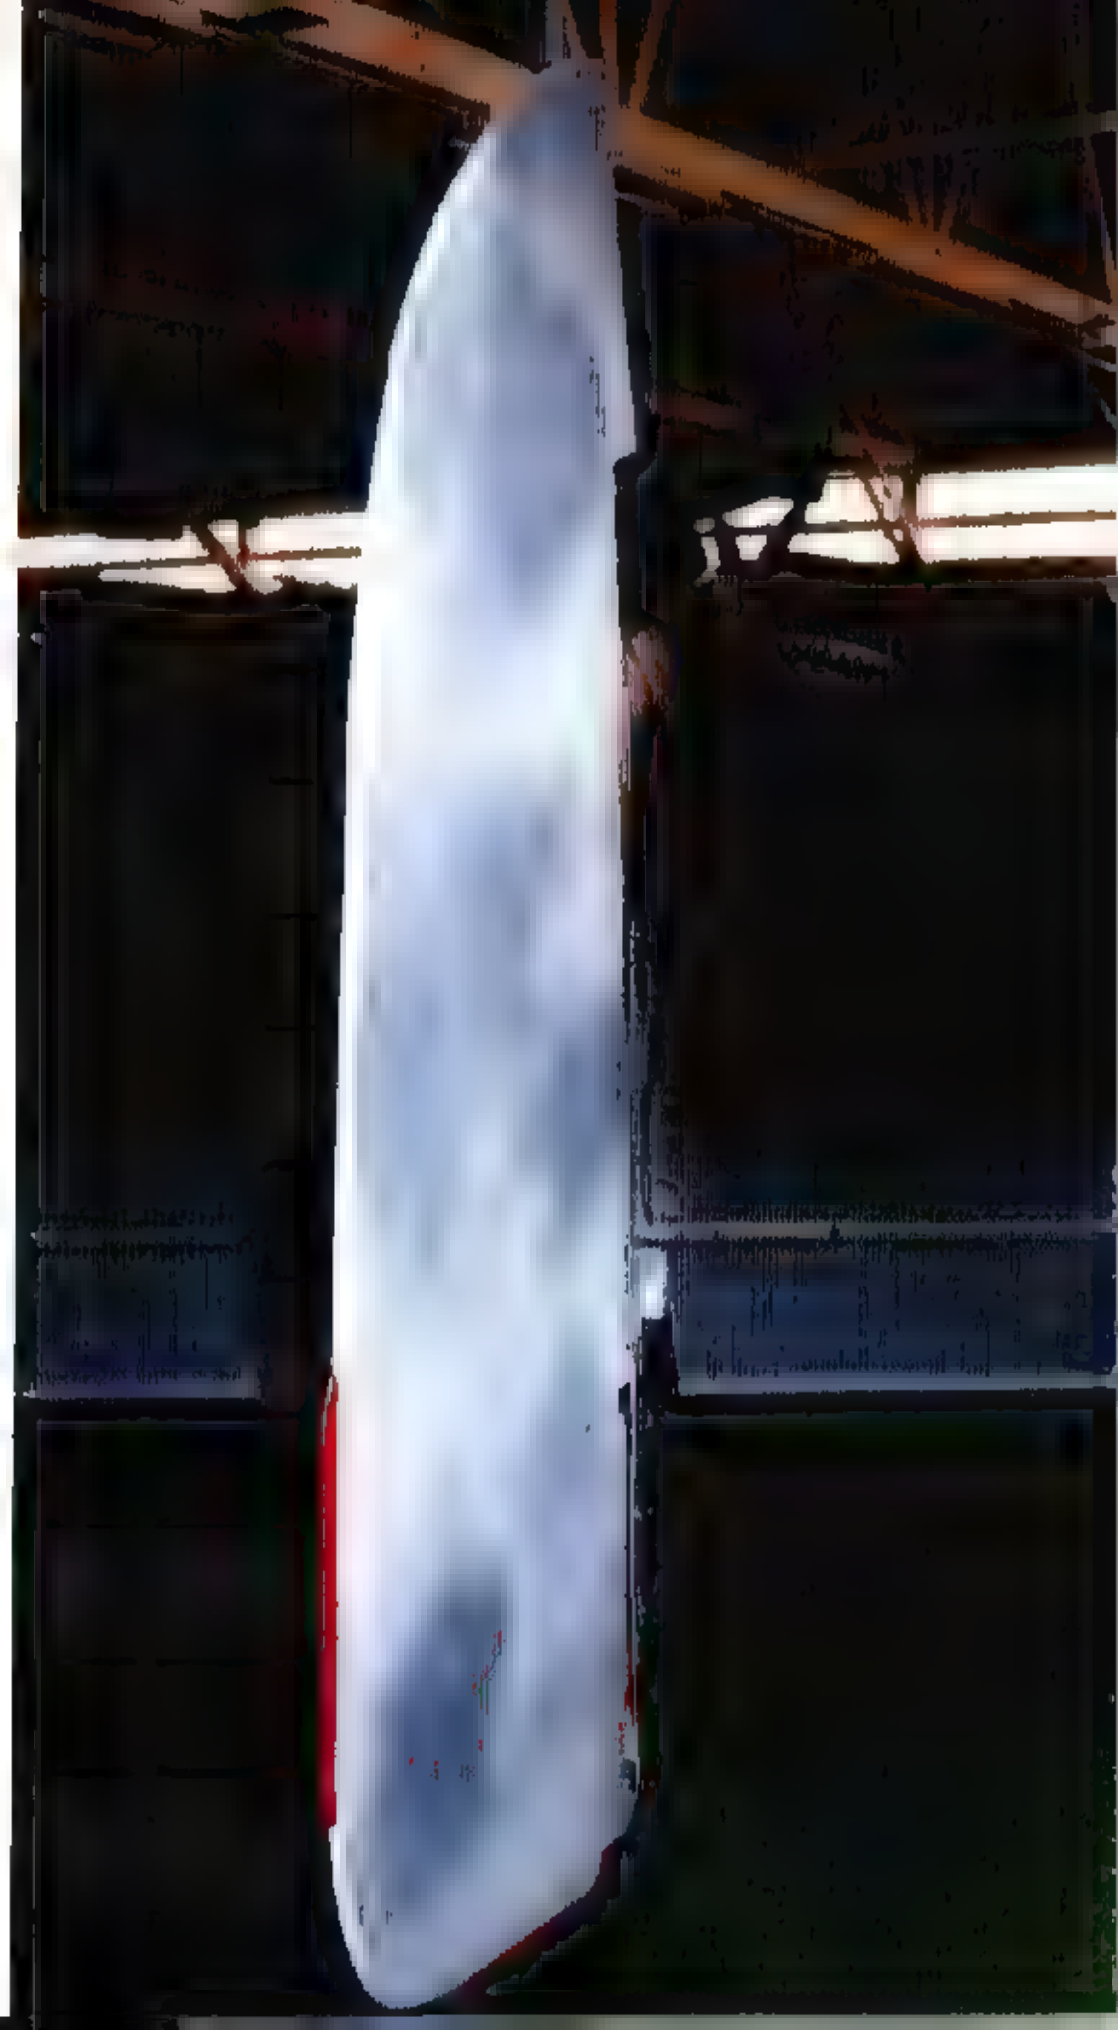
(Right) The replica rudder at full left deflection. The Fw 190 rudder had a cloth covering stitched to a heavy metal frame. The fixed metal trim tab is painted red. (Author: Ryle)

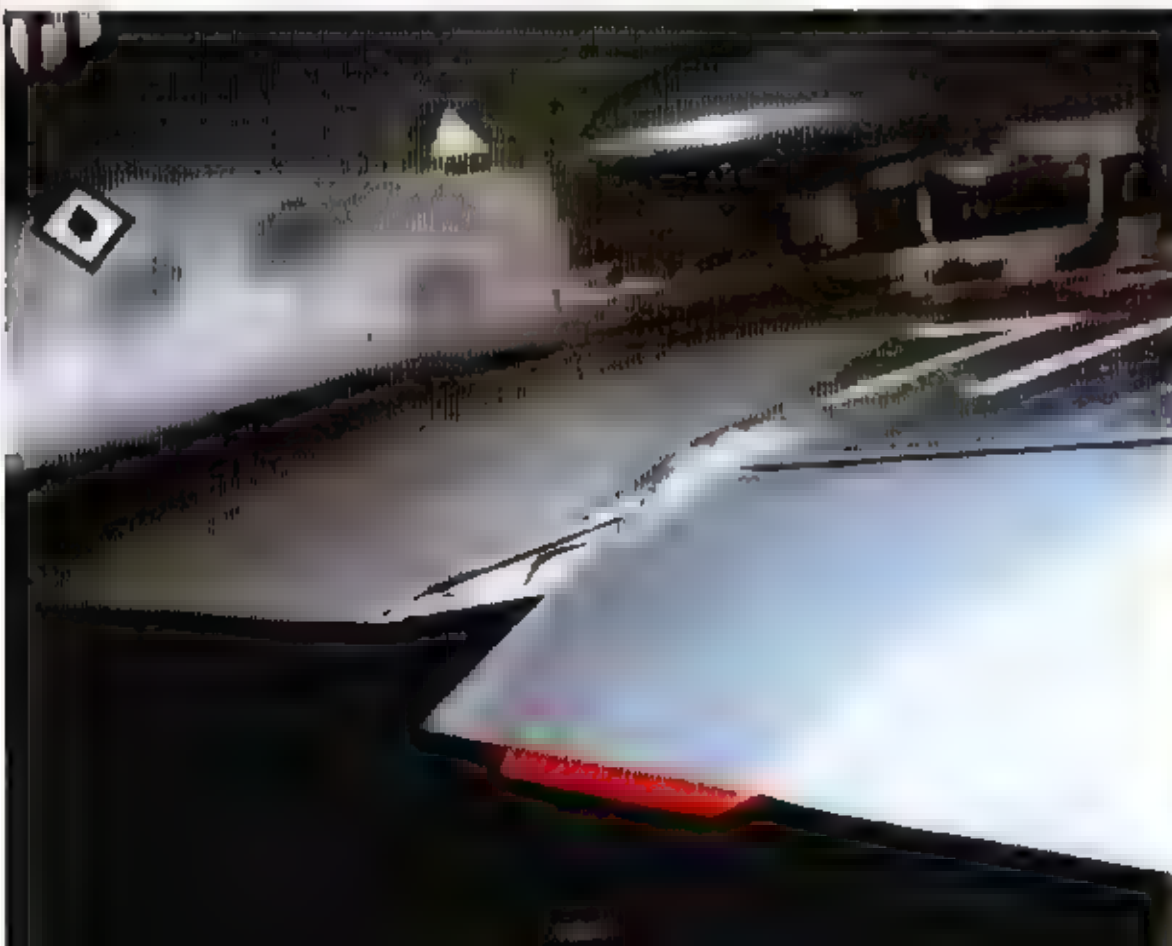
The starboard wing aileron in full up and in full down position. The aileron is cloth over a metal frame the same as the rudder and the elevators. Painted red, the metal trim tab is positioned quite close to the inboard edge of the aileron. (Author: Ryle)

The leading edge of the starboard wing has a small cover plate just outboard of the main gear which covers a hole originally intended for the MG FF 20mm cannon of an Fw 190A-0 through Fw 190A-5 aircraft. Since many Fw 190 wings were rebuilt and reused, these removable panels were used as fairings to cover the hole when the cannons were not fitted. (Author: Ryle)

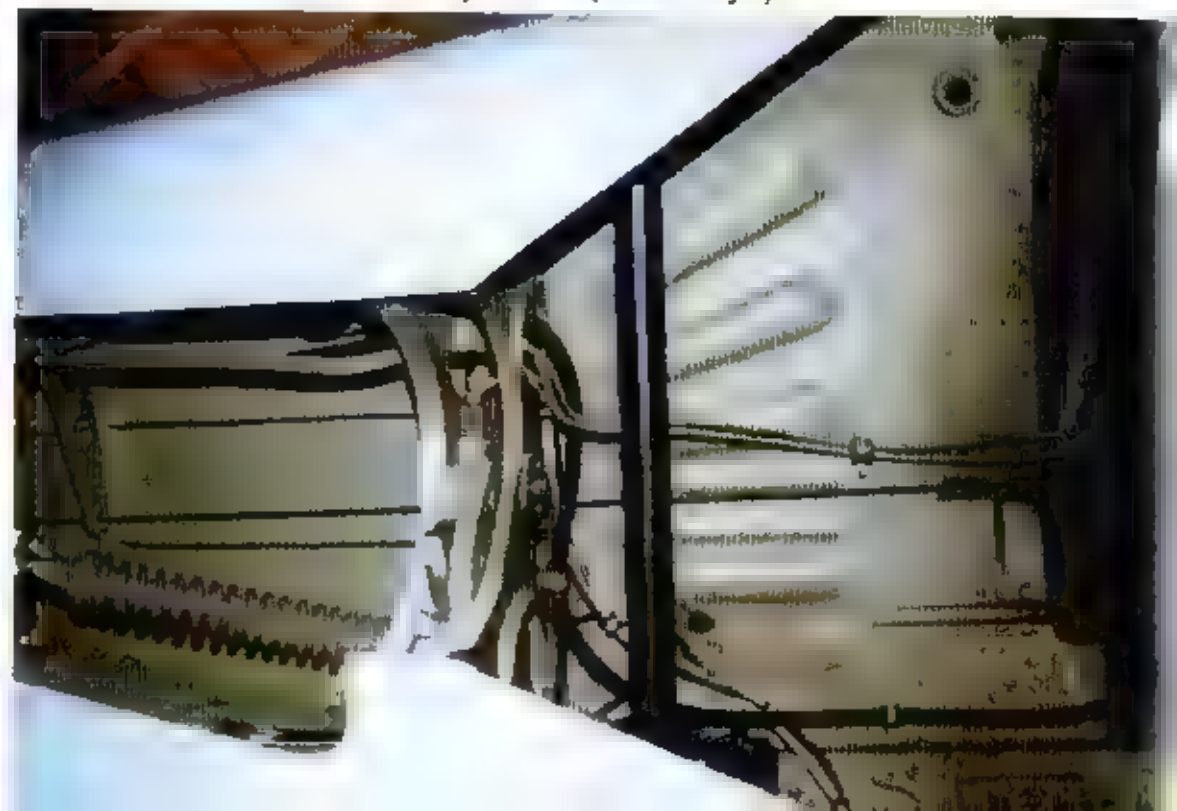
With the starboard under carriage down the rear of the engine can be seen. The 20mm cannon barrel can be seen (without a barrel shroud installed) as well as the inboard wing structure and landing gear up-lock assembly. The tail wheel retract wire runs through the center length of the wheel well to a pulley at the edge of the engine area. The wheel well is painted RLM 02 Gray-Green. (Author: Ryle)

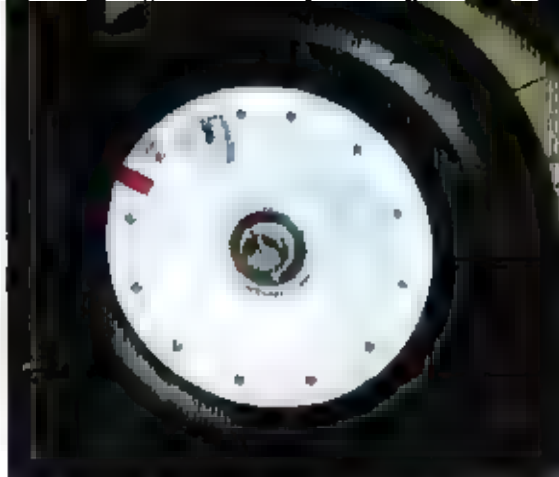
This late style wheel and tire are original. The wheel has a small yellow data tag between the red slip indicator and the triangular tire filler port. Most Fw 190 wheels were painted RLM 66 Black-Gray.

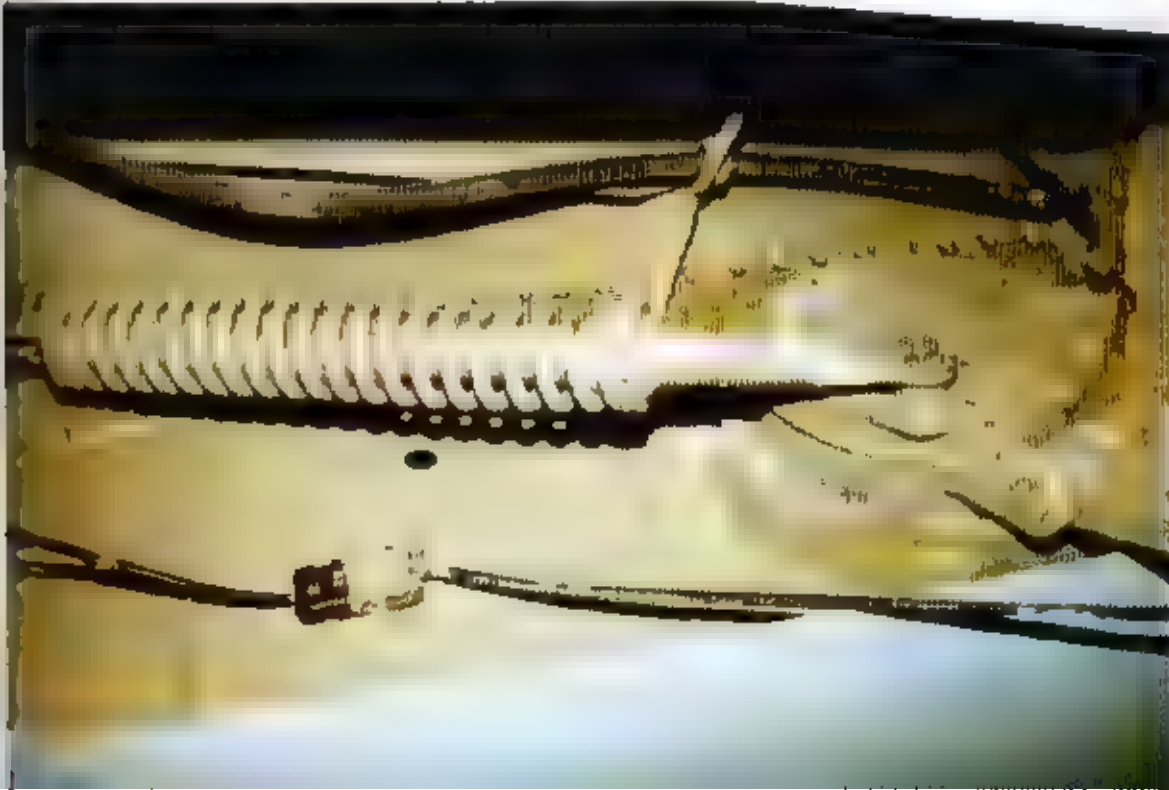
(Below) The port landing gear rotating drive unit mounted at the rear of the wheel well in the main wing spar. On the other side of the spar inside the wing is an electric motor used to raise and lower the landing gear. The spring covered rod is the 'sealed air jack' used along with the force of gravity to lower the gear if the electric motor was not available.

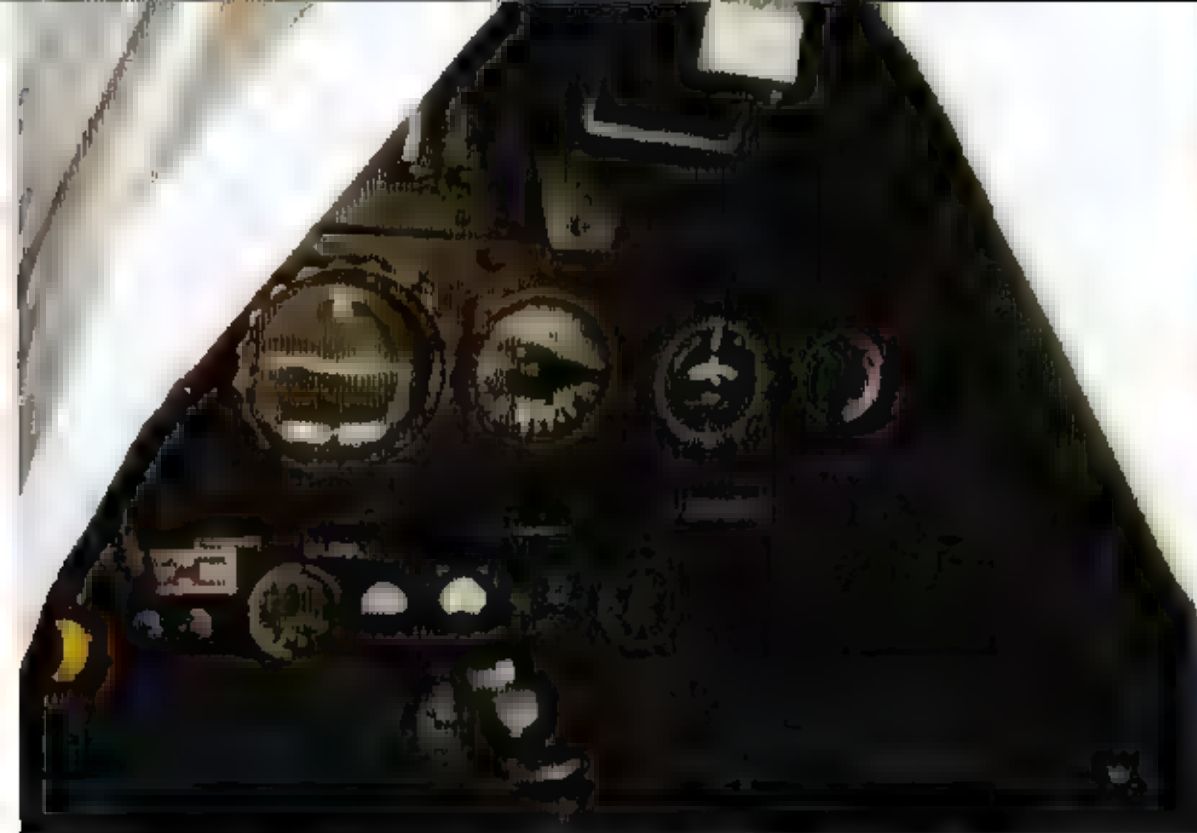
Two different styles of original rudder pedals are installed, which were usually installed like pairs, however with the continuous re-building of damaged machines this configuration could easily have happened. Behind the instrument vacuum flask is the fire wall with a Black metal plate covering the hole where the 20mm cannon's breech protruded into the cockpit. (Author: Ryle)

This instrument panel is not standard for an Fw 190D-9 but its configuration is within the variations seen on late war variant of the Fw 190D. The cockpit, including the instrument panel, would normally have been painted RLM 66 Black-Gray which is not as dark as the paint seen here. (Author: Ryle)

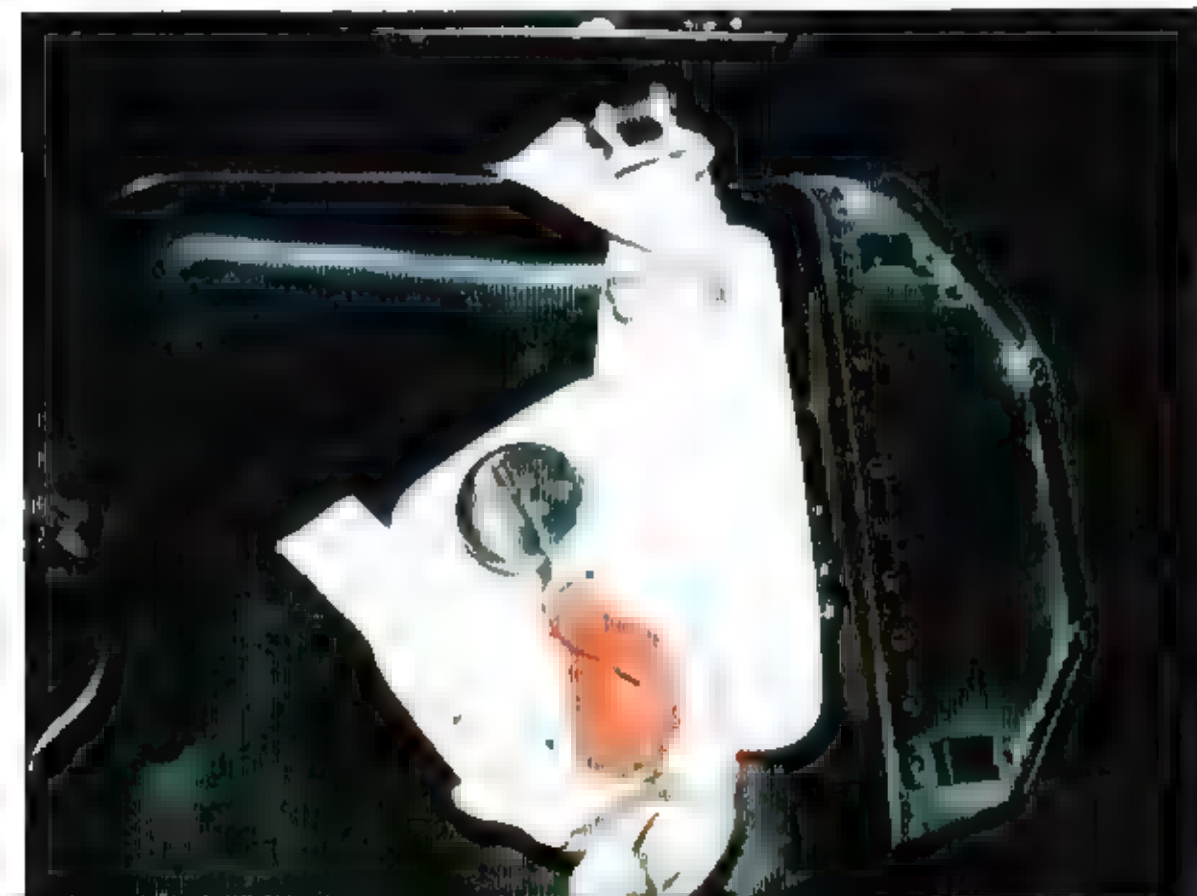
The 'oxygen group' of gauges, in blue on the lower instrument panel, are in front of the combat clock, which is mounted horizontally, on the forward portion of the right console. (Author: Ryle)

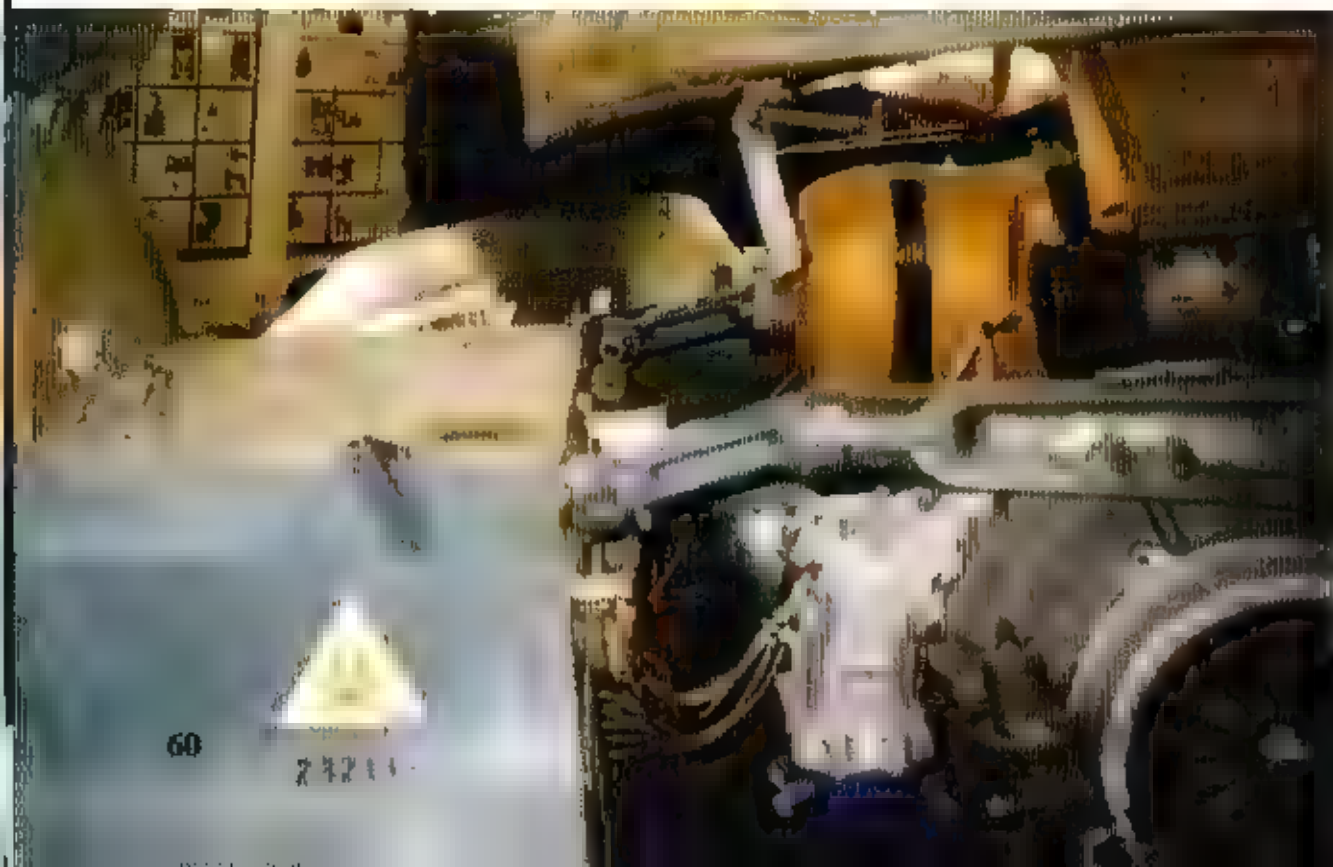
(Right) Looking directly down into the rear of the engine compartment at the fire wall. The upper engine bearer link bends slightly outward to attach to the fuselage brackets. The taped over pilot's air intake is on the fire wall to the left of the silver supercharger which has the generator partially overlapping it. Just above the pilot's air intake on the fire wall is the silver box containing the ignition relay. The yellow coolant tank is just above the silver oil tank. The starboard engine bearer curves slightly outward to meet the fuselage attachment. (Author: Laing via Goss)

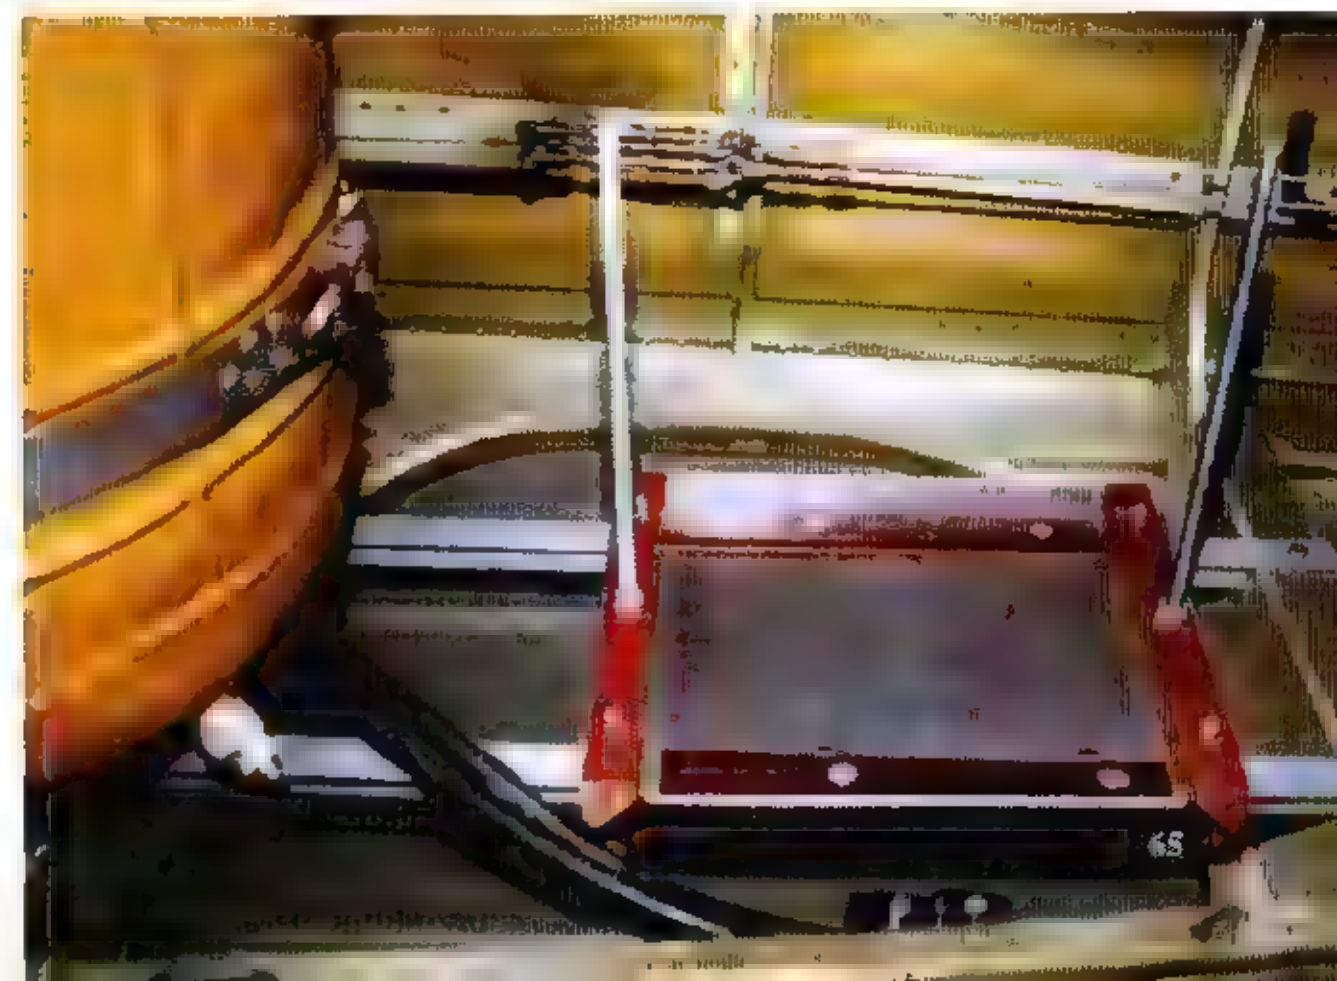
Looking at the floor of the fuselage through the port side, this machine has a metal auxiliary fuel tank access door frame. The bracket in the center of the photo is a battery holder added during restoration. (Author: Ryle)

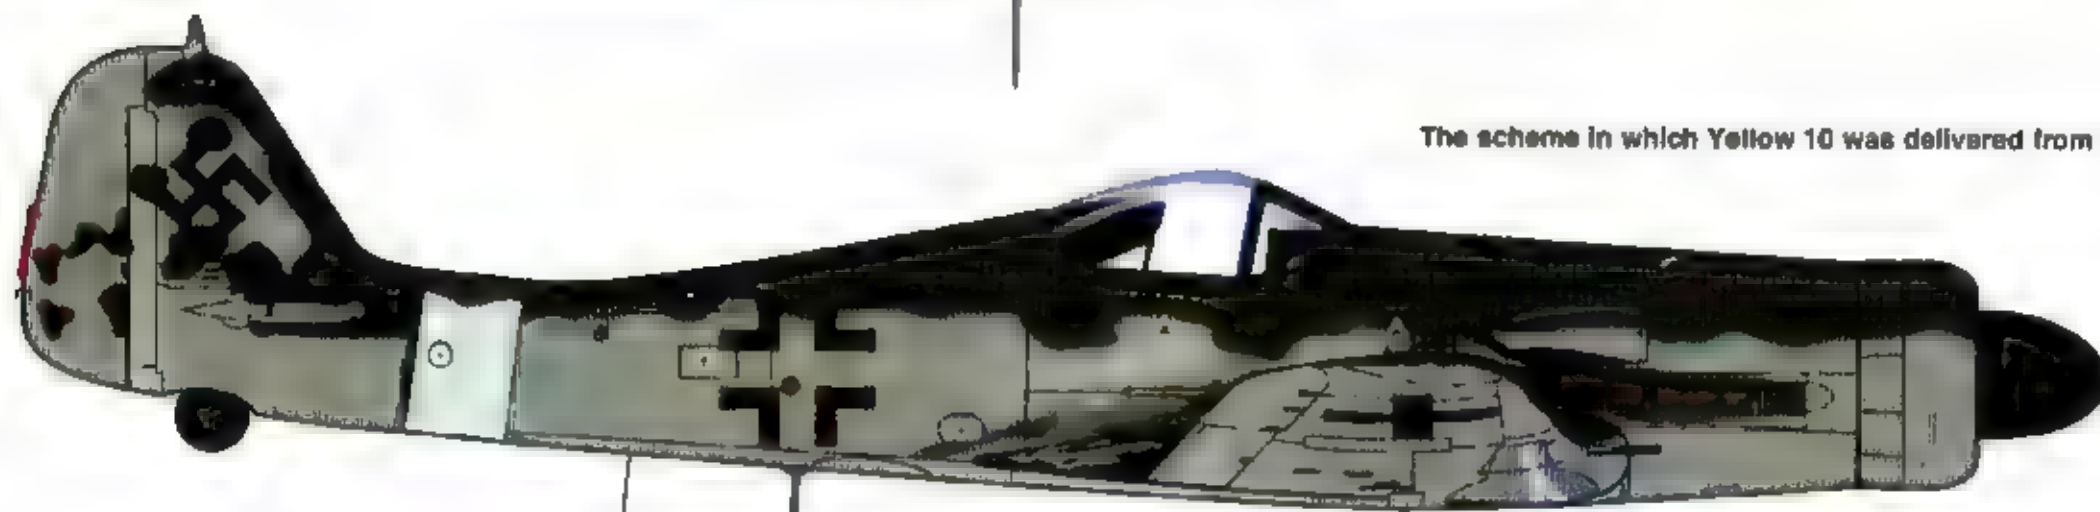
Yellow 10, an Fw 190D-13 (836017), of I/JG 26 was the aircraft flown by MAJ Franz Goetz, the last Kommodore of the Geschwader and was surrendered at Flensburg in May of 1945. Spinner is Green with a White spiral and 70 Black Green blades. The late war 'standard paint scheme' has been heavily painted

over for additional ground concealment. The fuselage is 75/76 with 81/82 over sprayed. The Ace of Spades is under the cockpit on both sides of the fuselage. The Defense of the Reich band is more vertical than the fuselage extension plug. The upper wing surfaces are 83/77 primer with 81/82 over spray, while the stabilizer is 76 with 81/82 over spray. The landing gear covers are natural metal.

Yellow 10 (W Nr 836017), an Fw 190D-13 of I/JG 26. Surrendered at Flensburg, it is now on display at the Champlin Fighter Museum. The small JG 53 *Pik As* (Ace of Spades) emblem can almost be seen under the cockpit just above the leading edge of the wing. (J. Ethell via Laing)
